Loss of AC Main' Investigation Report

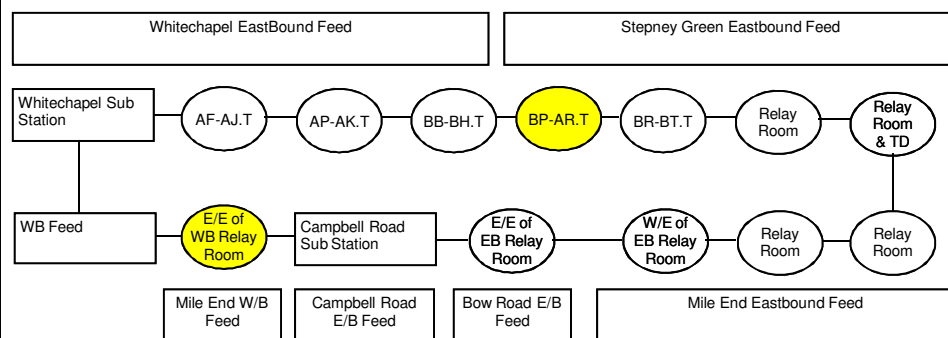
3. Point of Cause

- * The first Earth Leak was found to be the connection of the signal main at the Relay Room on the East End of the West Bound Relay Room caused by Poor Termination
- * The second Earth Leak was suspected to be the Link Box BP-AR.T as this was found to be full of water during the isolation investigations

- Direct Cause #1 : Poor Quality Installation on E/E of WB Relay Room
- Direct Cause #2 : Water Present in BP-AR.T Link Box

Poor Quality Installation	Earth Fault on BP-AR.T Link Box
Why : Poor Quality Installation	Why : Water Present in Box
Because : The New Cable was Incompatible with the New Gland	Because : Water was able to get into the box and unable to drain away
Why : Incompatible Cable and Gland	Why : Water able to enter box
Because : Incorrect Materials were selected for the Installation	Because : The Mark 1 Link Box does not seal correctly
Why : Incorrect Materials selected	Why : Does not seal correctly
Because : No Specification or Method Statement for a Temporary Installation	Because : The box does not have a method for diverting the water away from the seal
Why : No Specification	Why : No Diversion Method
Because : It was not anticipated that a temporary connection would be needed	Because : The design of the Mark 1 Link Box is not adequate for the operating conditions
Root Cause : Specification for Temporary Repairs not included in Project Scope	Root Cause : Design of Mark 1 Box not suitable for operating conditons

Item	Root Cause	Countermeasure	Date	Status
1	Correct Materials Not Available	40mm Dia Cable Gland & Plate to be specified in Method Statement	OH	Comp
		40mm Dia Cable Gland & Plate to be made available in stores	OH	Comp
2	AC Main Switch Box Installation	Modify Method Statement to include Temporary Repair Instructions	OH	Comp
3	Other Temporary Installations	Confirm if other similar Installations are currently on-going	OH	Comp
4	Water Ingress into Link Box	Check condition of all existing Mk1 Link Boxes	PW	Comp
5	Water Ingress into Link Box	Check Condition of Seals on Link Boxes and Adjust if possible	PW	Comp
